TECHNICAL REPORT E-79-6

FAILURE ANALYSIS INVESTIGATION OF  
NIKE-HERCULES HOISTING CHAIN

U.S. ARMY  
MISSILE  
RESEARCH  
AND  
DEVELOPMENT  
COMMAND

22 December 1978

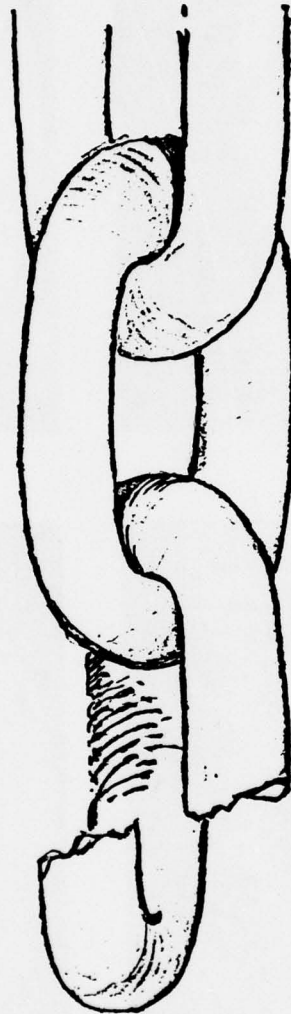
Reports received from NEAS (Dave Kutz) were that the chain failed during lifting and handling of the missile, and that upon failure the missile dropped approximately 6 in. (15.24 cm) before coming to rest. Failure in the chain link was approximately 2-ft (0.61-m) above the chain hook.

Approximately 12 ft (3.7 m) of the chain was received from DRSMI-NSS with the failed link attached to the main chain body as shown in Figure 1.

Figure 1. Isometric representation of NIKE-HERCULES hoisting chain as received.

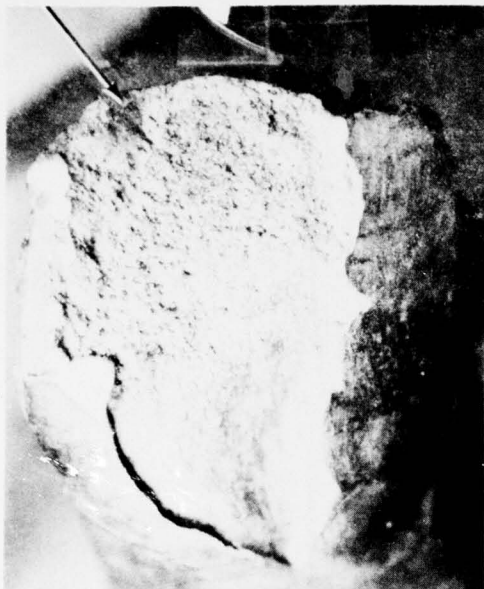
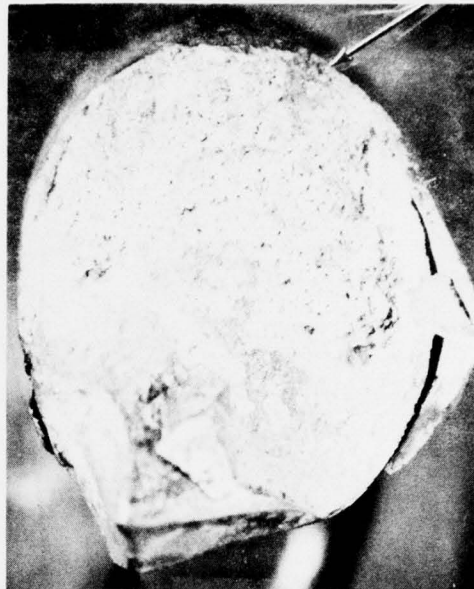
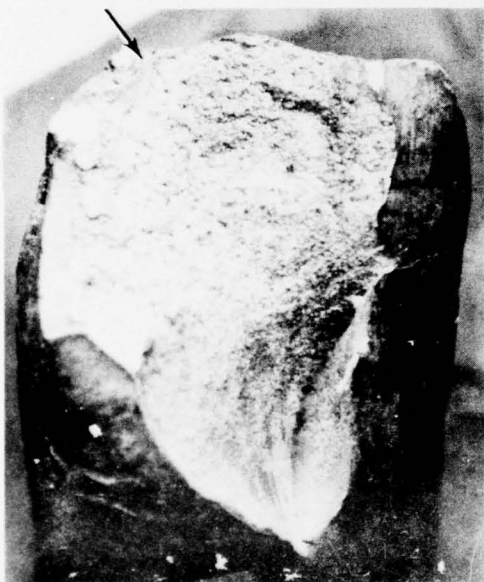
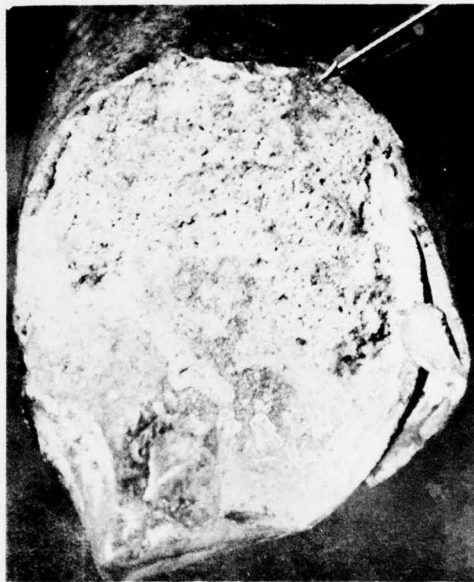
The failed link of chain was cut from its present link and macrographs of the fracture surface were taken. Figure 2 shows the mirror image fracture surfaces with the origin of failure indicated.

Because of the previously mentioned findings it is the opinion of the Materials Engineering and Development Laboratory that the chain failure was caused by an overloading condition and that the failure initiation site is as shown in Figure 2.

Figure 2. Macrograph mirror image of fracture surface  
(fracture origin at arrow) (magnification 6X).

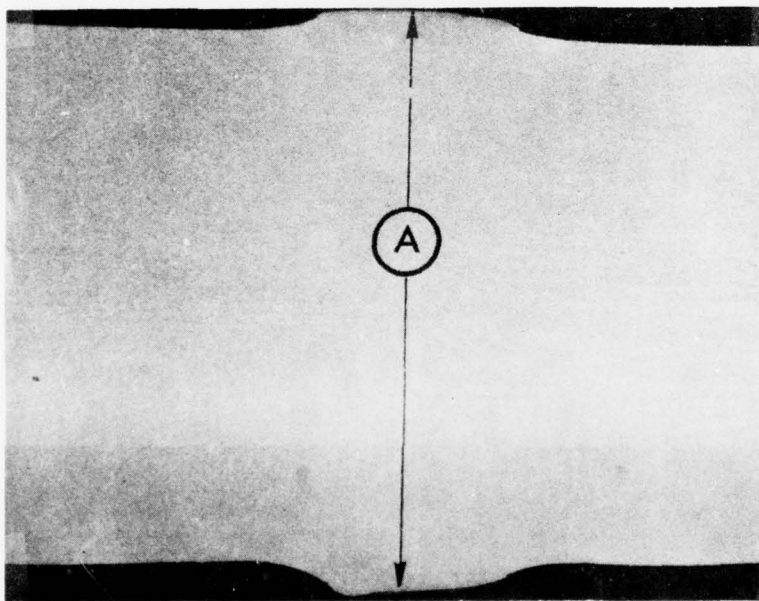
Figure 4 is a macrograph of the new chain weld area. Further metallurgical examination of this weld at 400X did not reveal any voids and/or cracks.

Figure 4. Typical weld area (new chain)(magnification 6X).

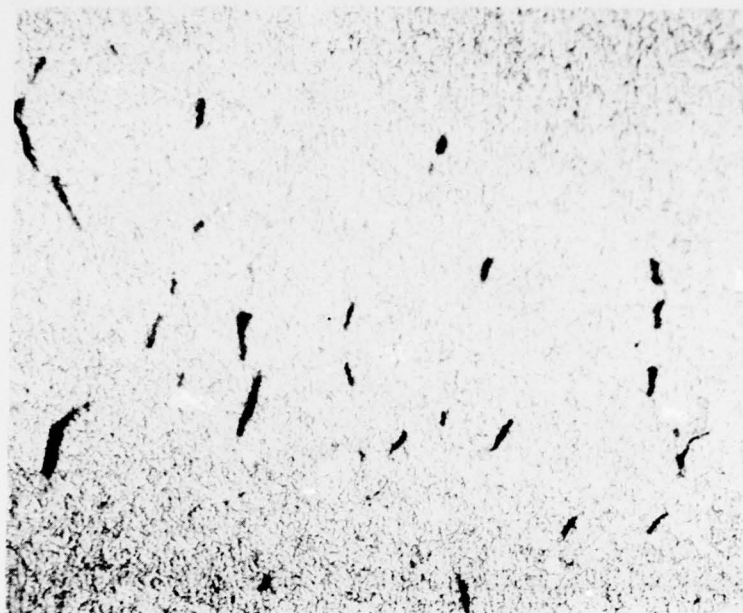
The metallurgical examination of the weld area, Figures 5 and 6, revealed cracks and voids in the old chain are representative of a typical welded chain link. The maximum depth of these internal cracks is 0.0022 in. (0.057 mm) as shown by Area (A) of Figure 6. (This scale factor is 0.4 in. = 0.0001 in.) The macrograph of the old chain weld area (Figure 3, Area C) shows surface cracks, the maximum depth of which is 0.0166 in. (0.4 mm). (This scale factor is 0.1 in. = 0.0166 in.)

Figure 5. Micrograph of Area (A) of Figure 3 (magnification 400X).

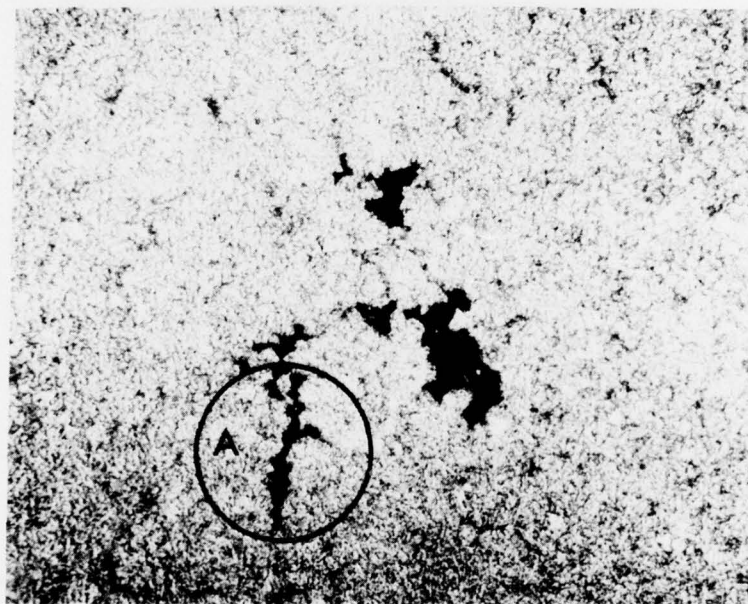
Previous studies conducted in the area of notch sensitivity of chains<sup>1</sup> of this alloy type indicate that this chain is virtually unaffected by the presence of a 0.1-in. (2.54-mm) deep flaw. As a result of this study one can readily see that the 0.0022-in. (0.057-mm) and 0.0166-in. (0.4-mm) crack depths, Figures 6 (Area (A)) and 3 (Area (C)), respectively, are of no serious consequence to sudden fracture of chains investigated in this study.

Figure 6. Micrograph of Area (B) of Figure 3.

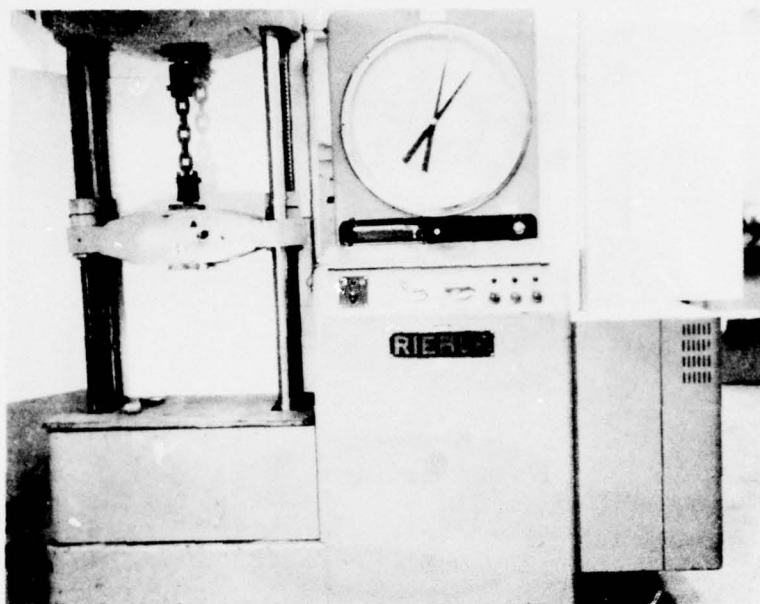
Figure 7. Typical tension to failure test setup.

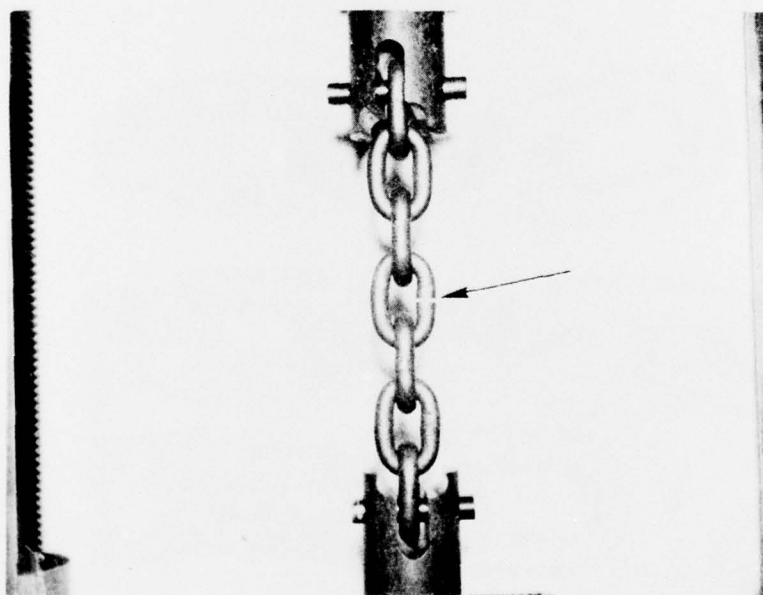
The tensile test conducted on the old chain with the weld cut through (Figure 8) exhibited an upper load limit of 6450 lb (28.7 KN). This link had an initial opening of 0.0700 in. (1.78 mm) at zero load. Deflection measurements were taken at five different load levels by stopping the test machine and using a feeler gage to measure the displacement in the cut link.

Figure 8. Tension test with weld area cut through (old chain).

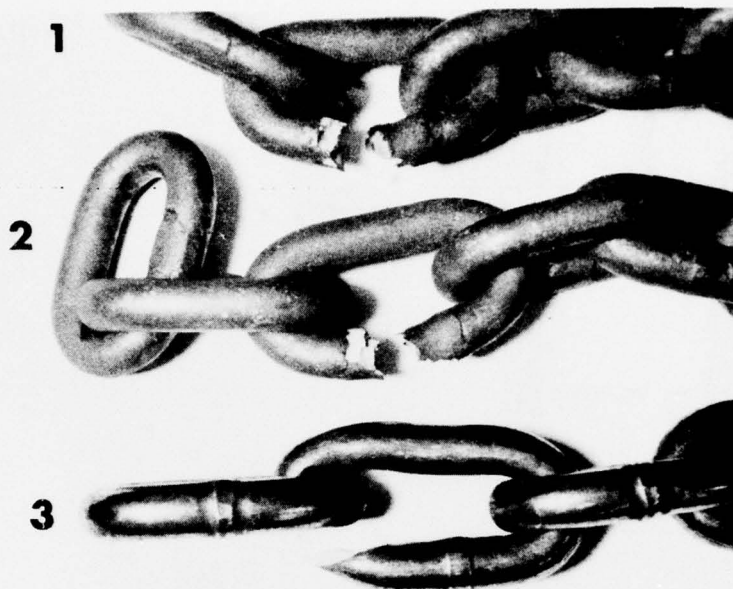
It should be noted that the fracture area in the old chain was through the weld area, while the new chain fractured in the base metal (Figures 9 and 10). This mode of failure is primarily because of the smaller effective weld area in the old chain. [See Figure 3, Area ① dimension, and Figure 4, Area ② dimension, for respective diameters of 0.482 in. (1.22 cm) and 0.550 in. (1.4 cm).]

Figure 9. Chain tensile failures on old chain Nos. 1 and 2, and new chain No. 3.

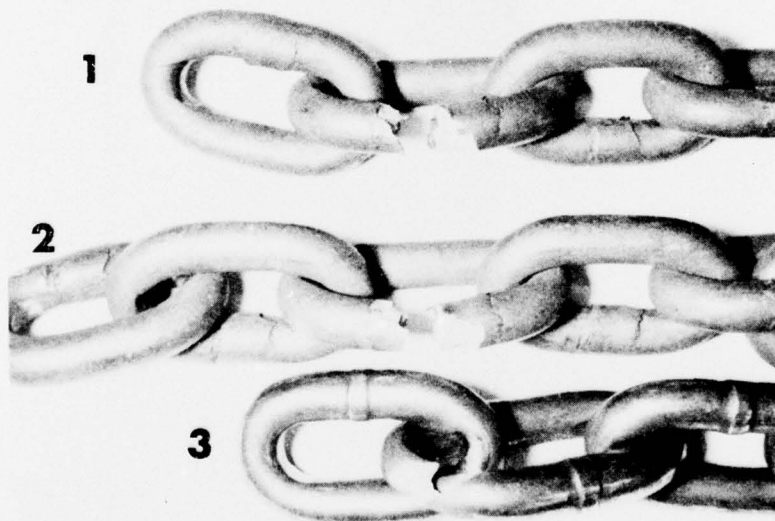
Figure 10. Chain tensile failures on old chain Nos. 1 and 2, and new chain No. 3.

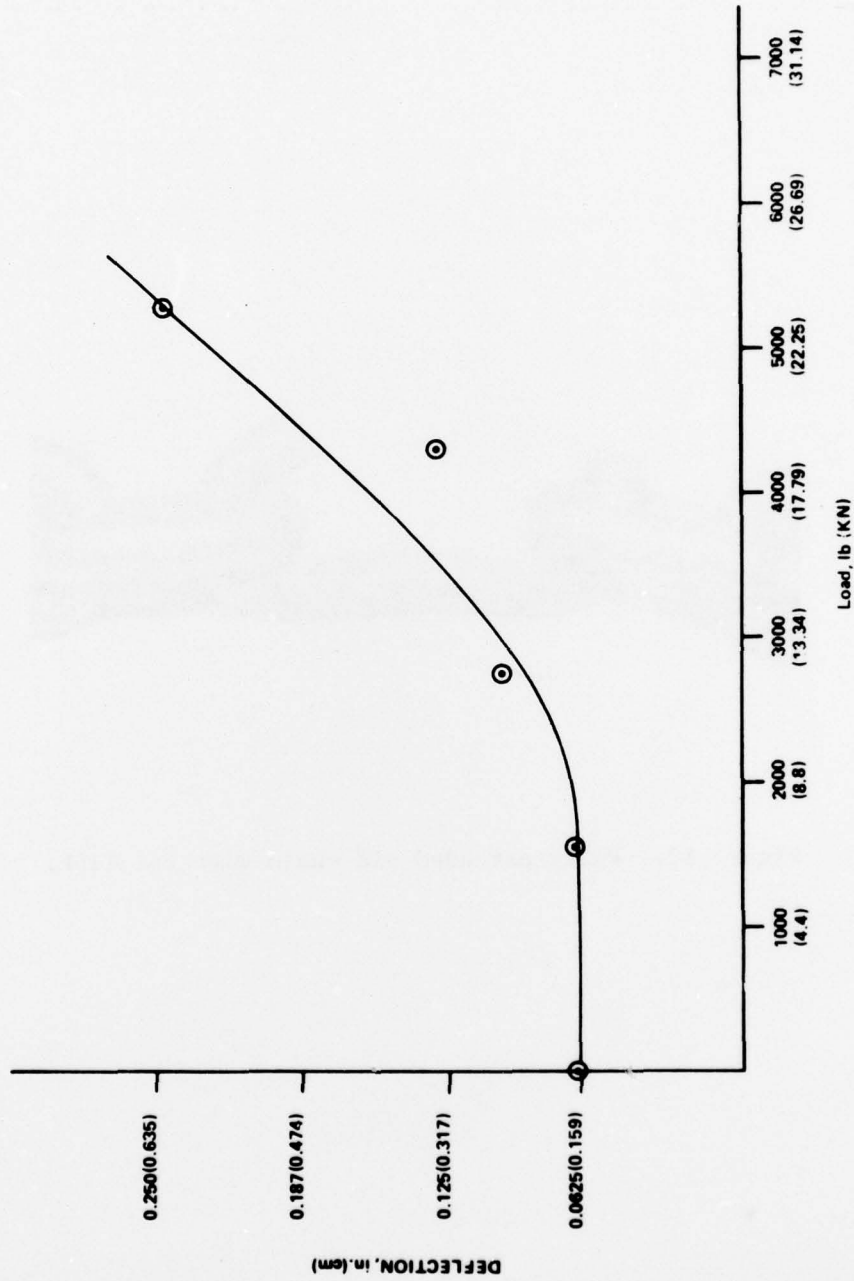
The cut opening increased in size as loading increased on the chain link. When the load level reached 6450 lb (29.6 KN) there was no further load increase (Figure 11), and the cut link extended and became disengaged from its parent link (Figure 12).

Figure 11. Load deflection curve of old chain with cut through weld.

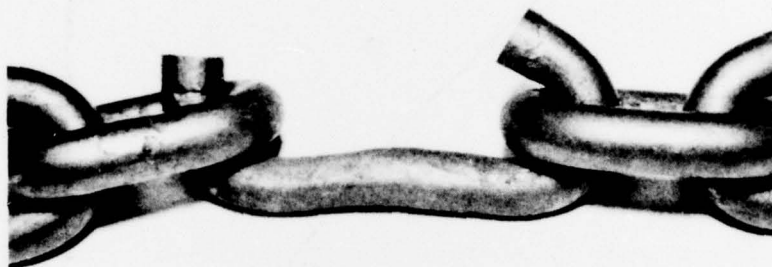
Figure 12. Fully extended old chain with cut link.
